IMCA Safety Flash 21/16

August 2016

Focus: Equipment Failure

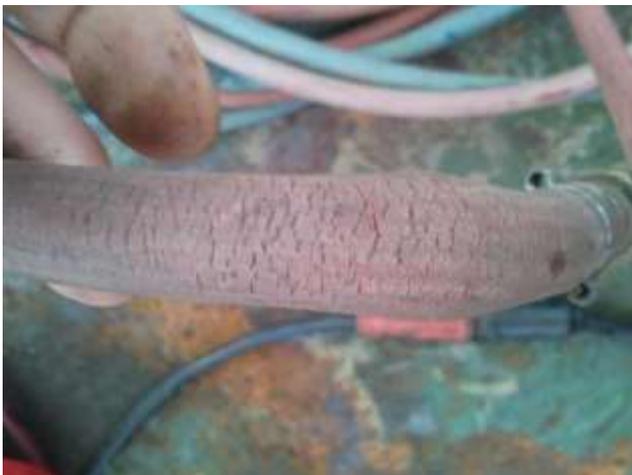
Left: work-hardened and perished hoses

- ◆ Repair or replace leaking components immediately;
- ◆ Remove damaged or leaking sections of hose, do not attempt to repair;
- ◆ Refit hose tails using crimp clips designed for that task;

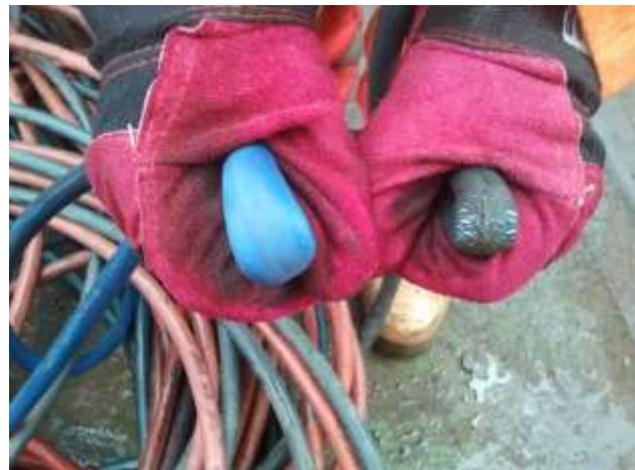
Right: difference between new and old hoses

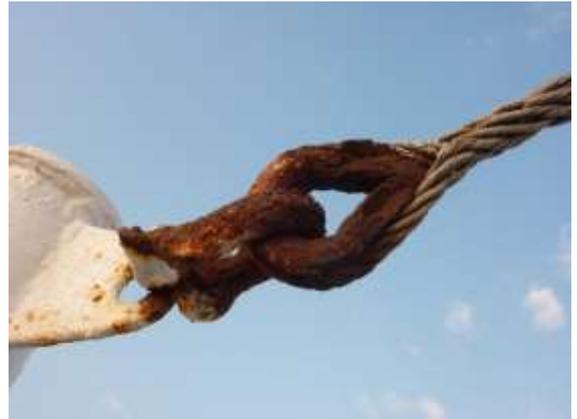
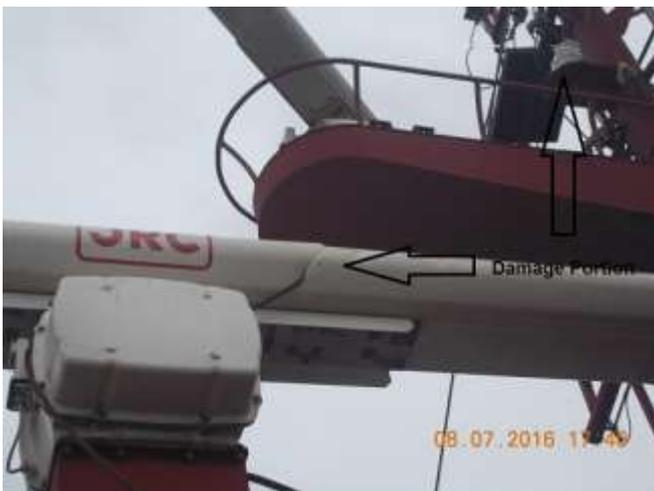
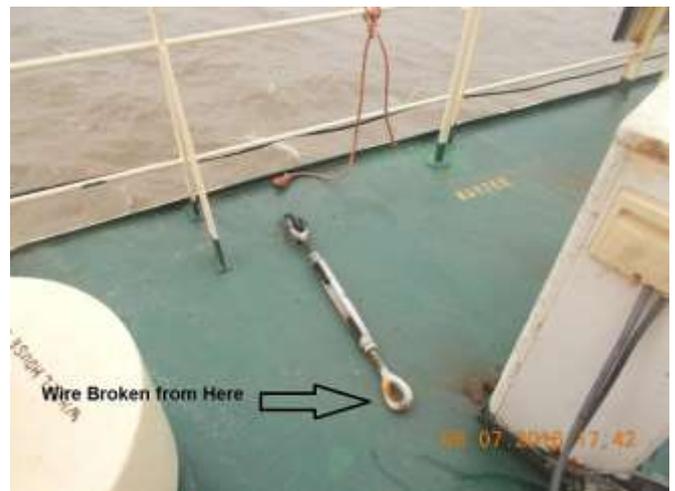
A member has reported an incident in which one of the wire stays securing a mast head, parted. A deck officer on watch heard a loud metal banging sound on the monkey island deck. Immediately both the radars switched off and someone was sent to investigate. One set of mast head securing wires (the port side) had parted from the long bottle screw and the strop had become entangled with a radar scanner. As a result, there was damage to the front side (radiation side) of the radar scanner cover, and the lower lamp assembly for the main mast head lights was damaged. The entangled strop was cleared away; temporary repairs were made to the radar scanner, and both radars tried out again.

The root cause of the incident was inadequate maintenance and inspection – failure to notice corrosion and impending failure.

Our member suggested that all similar securing arrangements should be inspected and tightened periodically and renewed or replaced, as necessary. Extra attention should be paid to all lashing and securing arrangement when heavy weather is prevalent.

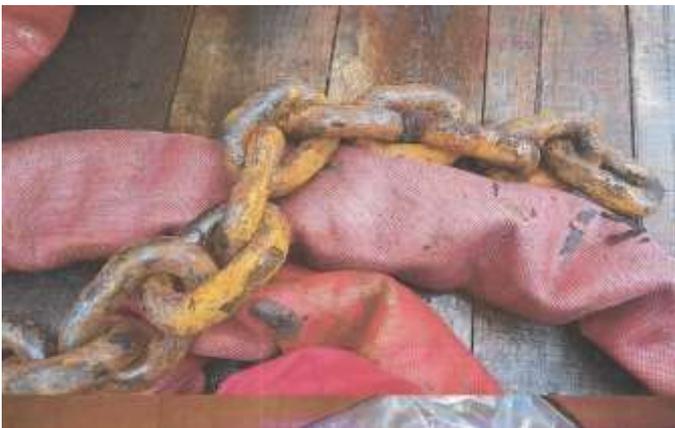
A member has reported an incident in which a chain parted during the recovery of a hyperbaric lifeboat (HLB) during routine testing and maintenance. On recovery of the HLB the vessel crane started the lift and when the weight on the crane load readout was approximately 7 tonnes, one leg of the chain set parted when two links split through their link ends. Since the HLB had not yet been fully lifted out of the water the drop was minimal and the parted chain dropped back onto the top of the HLB. There was no damage to the HLB shell due to the soft covering over the chain links.

Chain link and protective cover

- ◆ All HLB lifting chain sets should be re-inspected by full removal of the protective covering to gain complete access to each link for a thorough visual inspection;
- ◆ The inspection should be conducted by an authorised authority against an acceptable industry standard of acceptance criteria with emphasis on wear, cracks, pitting and corrosion.

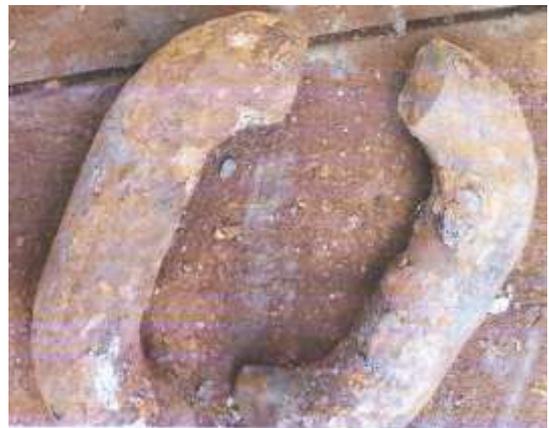
Chain link failure

- ◆ Periodic inspections of the chain were in date and on record;
- ◆ Significant corrosion was discovered on the chain, raising concern about the pass/fail criteria used on the previous visual inspection;
- ◆ The cross section of the failure locations revealed corrosion indicating the presence of cracks prior to failure;
- ◆ The protective covering is a potential obstruction to thorough and effective inspection of the individual chain links;
- ◆ Environmental conditions at the time of the incident were stable and could not have contributed to high impact loads;
- ◆ The chain set has been returned to the manufacturer for mechanical testing and analysis. The results of this testing are pending.

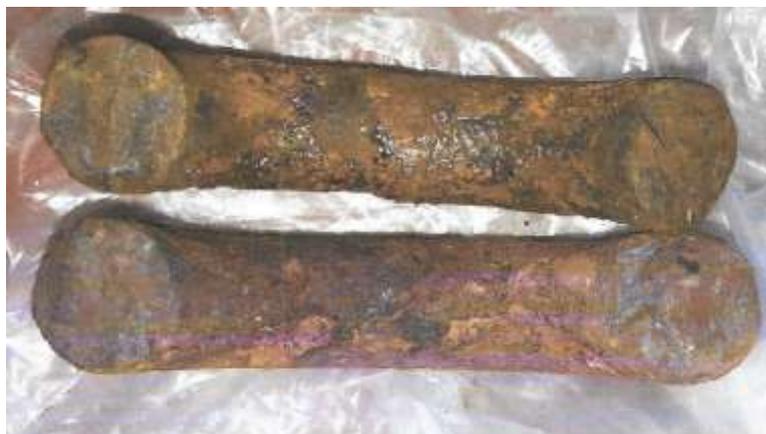
Corrosion on cross section of failure zones
