# Safety Alert

**Number: 18-07**

**Subject: AB Lifted by Crane – High Potential Near Miss**

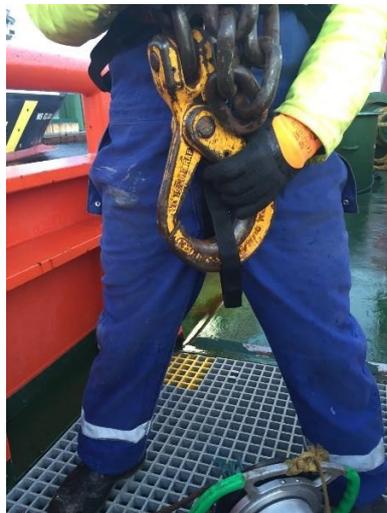
## Photographs / Supporting Information

As the hose was landed on the vessel deck, one of the AB's went to release the hook from the lifting sling. While slightly bending forward and down to clear the hook, the crotch strap on the AB's lifejacket formed a larger than normal bight. As the AB released the hook it was incorrectly placed inside the bight and as he returned to the upright position the hook was caught. Unfortunately, the AB did not notice this, and then subsequently signalled to the crane operator to "hoist". This resulted in the AB being lifted above the deck and out over the side of the vessel. The AB's immediate reaction was to hold onto the pennant wire to keep tension off the crotch strap. The crane driver and second AB quickly became aware of the situation and were able to land the AB safely back on deck. The duration of the incident was in the region of 11 seconds from the AB being lifted and returned to deck.

- The crotch strap on the lifejacket was not suitably tightened on this occasion. A change in body posture created a larger than normal "bight" which allowed the hook to be attached.
- The hook and lifting sling landing directly on the deck of the vessel.
- AB's posture during the disconnection of hook.
- A momentary lack of awareness on the actual location of the hook, i.e. left open, close to the body, the signal to hoist.

- Hook awareness - ensure hook is clear of the body and any snagging hazards.
- Buddy check during the toolbox talk prior to task commencement.
- Raise awareness across fleet for all lifting operations.
- Discuss with Industry and fleet deck crews on a suitable "pause point" prior to giving signal to crane operator.
