WA Member Incident

March 2024: Finger entrapment whilst mooring

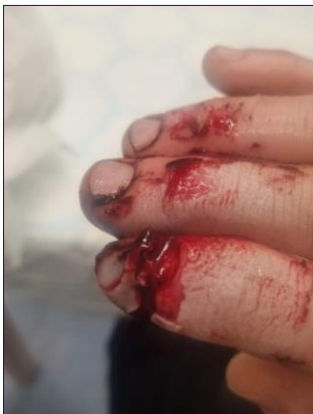
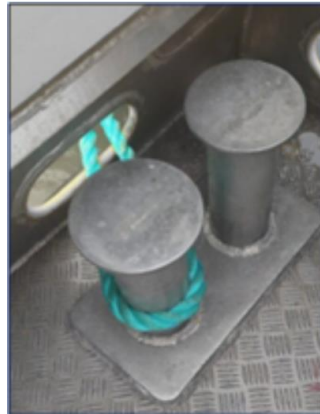
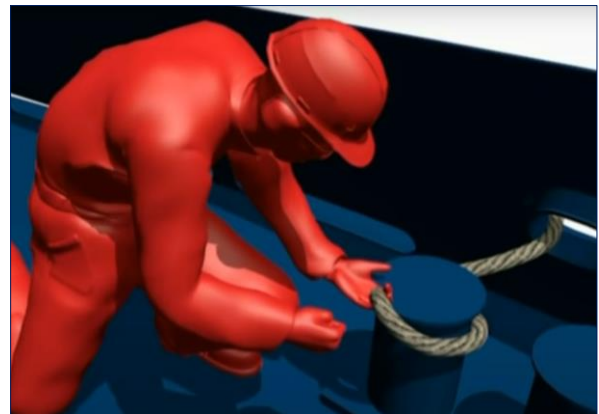
The vessel was headed to the pontoon to moor alongside her regular berth. As the vessels aft port quarter came alongside the pontoon, the deckhand used the boat hook to pick up the 'in-situ' mooring line and began the process of feeding the spliced eye through the fairlead. They then began placing the line over the bitts, this is where the deckhands' fingers on his right hand became trapped, and serious injuries were sustained to three fingers.

Immediate Causes – There was insufficient slack in the mooring line to allow the task to be completed safely, The vessel was moving forward as the task was performed, No assessment for PPE worn by the crew for this task with regards to impact gloves, Newest and least experienced deckhand completing the task and only a mooring line with a splice eye available.

Root Cause – Lack of Risk Perception.

The investigation highlighted several corrective actions to be put in place; Vessels to complete a Toolbox Talk of their mooring arrangements, Company to review TBT for improvement suggestions, review of the mooring risk assessment and procedure, Safety alert to be generated and sent to the fleet, Trial of high impact gloves, Review of training and follow up supervision and review of design of vessel mooring arrangements

Ensure that sufficient slack is allowed when handling mooring lines. Where practicable, vessel should be stopped before mooring lines are placed over bitts, bollards, or cleats. Each task should be assessed fully to evaluate what additional mitigation measures could be used. Ensure new personnel (persons who are not yet experienced on a particular vessel) are appropriately familiarised. The use of single ended lines or the use of small rope extensions on the spliced eyes would avoid exposing fingers and hands to risk.
